November 16, 2018

Mr. Michael Vendetti  
Bonnet Shores Fire District  
130 Bonnet Shores Road  
Narragansett, Rhode Island

**Subject: Bonnet Shores Project Summary  
Flooding Mitigation Recommendations**

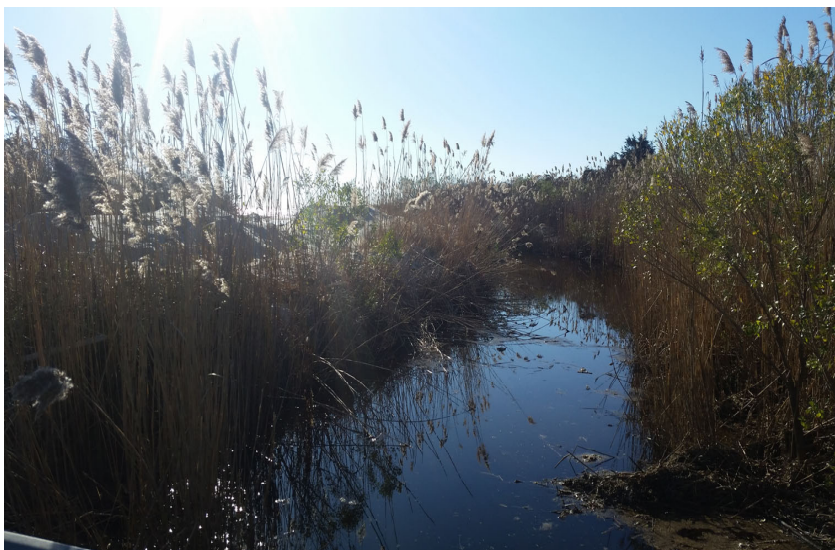
1) Nov. 27, 2017. Outlet channel (Beach Side)

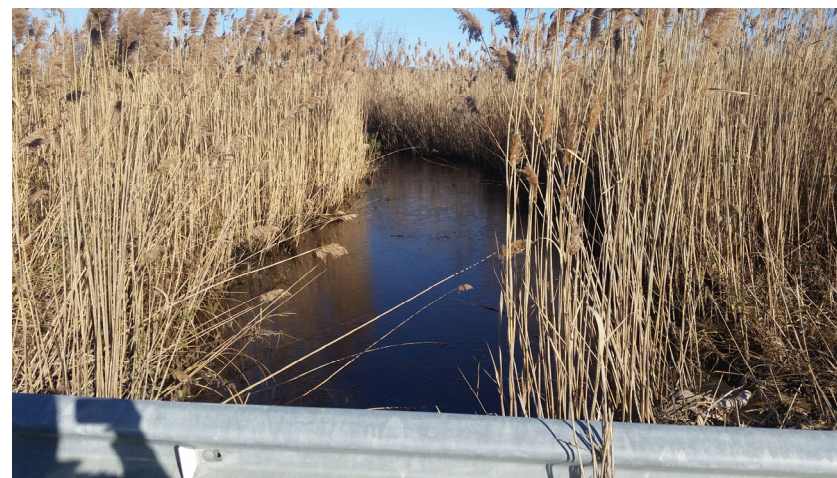
2) Nov. 27, 2017. Outlet channel (Pond Side)

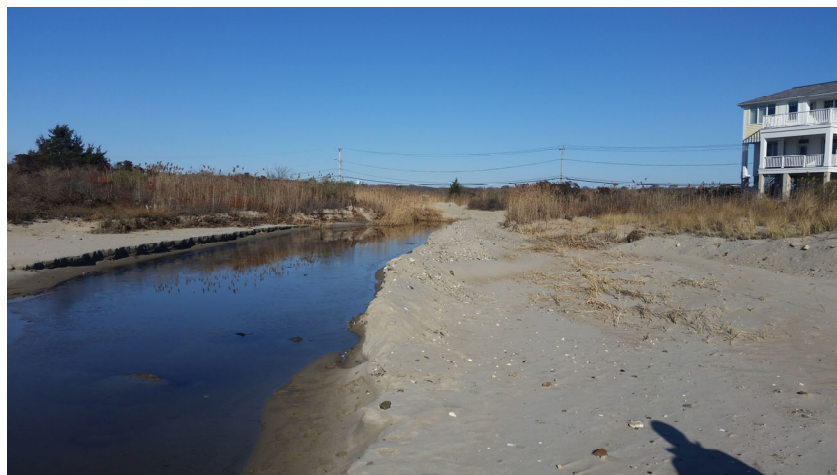
3) Nov. 27, 2017. Beach Side Channel looking toward road

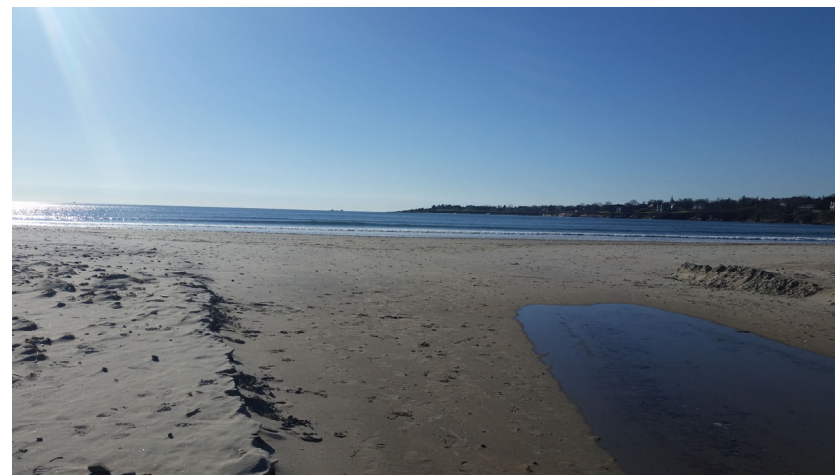
4) Nov. 27, 2017. Beach outlet

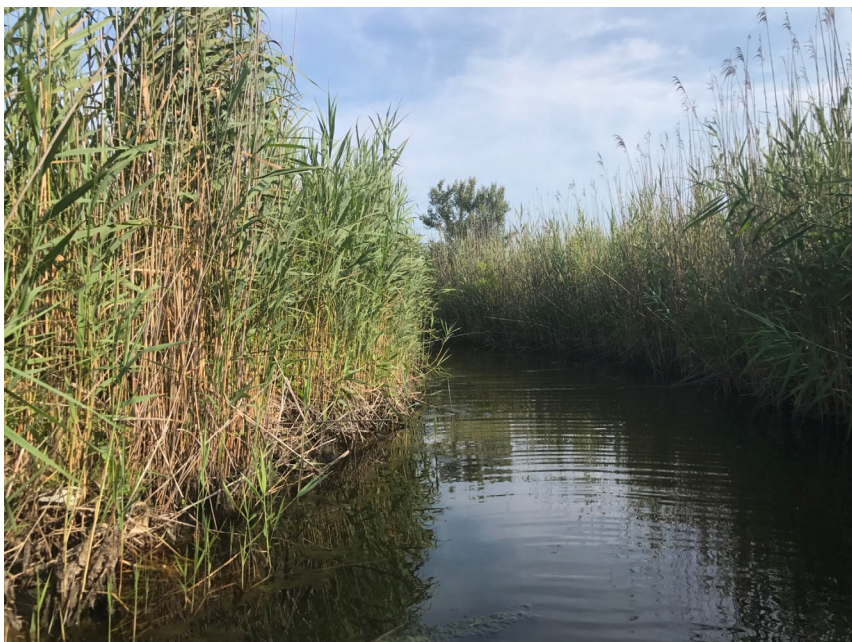
The dredging and removal of accumulated sand located at the beginning of the outlet channel will clear and allow clear passage toward the box culvert, however sand accumulation of the outlet channel on the beach side reduces the outlet flow from the box culvert, this channel should also be cleared and maintained. We understand during the summer season, the outflow channel on the beach side is not fully cleared.

5) August 07, 2018. Outlet channel (Beach Side)

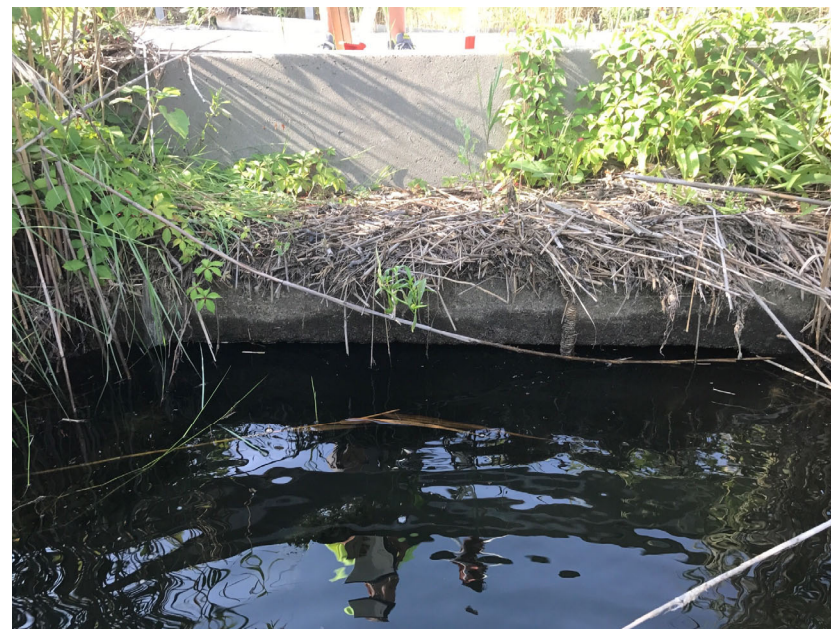
6) August 07, 2018 Concrete box culvert (Pond Side)

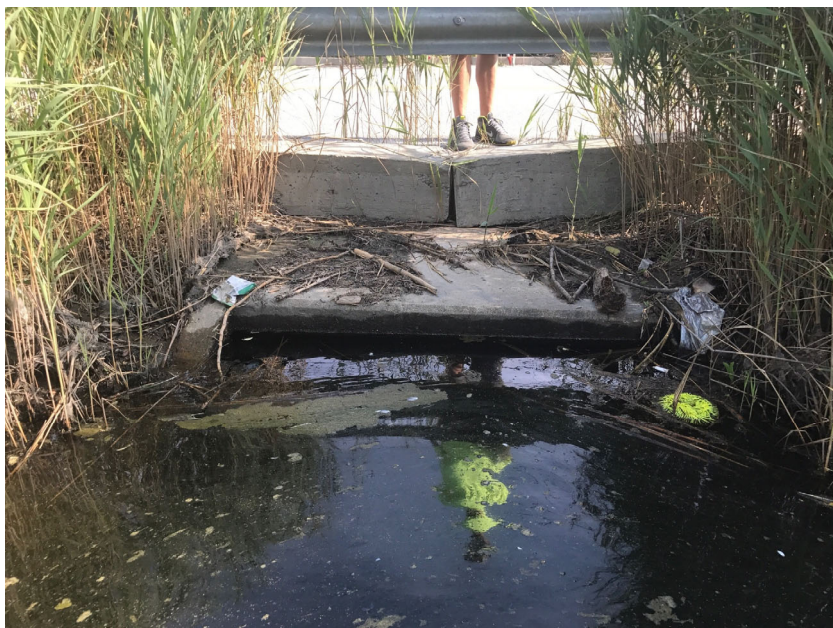
7) August 07, 2018 Concrete box culvert (Beach Side).

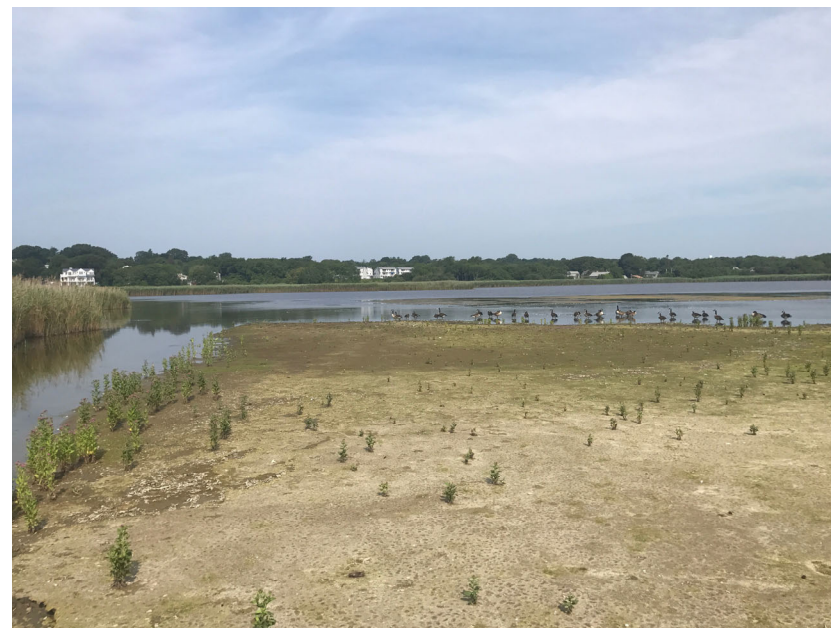
An elevation survey was conducted on August 6, 2018. The roadway elevation at the two (2) equalizer culverts are 3.35+/- and 3.50 +/- . The pond elevation during field survey on August 6, 2018 was 2.75 +/- . A field survey of the sand deposit area located at the beginning of the outlet channel was conducted and found to be approximately 30,000 sf area of accumulated sand with elevation varying from 3.16 to 2.79.

8) August 07, 2018. Accumulated Sand Delta (Pond)

1. Dredge and remove accumulated sand located at the beginning of the outlet channel to clear passage toward the box culvert. The sand delta varies in elevation from 1.71 to 3.16, we recommend dredging approximate three (3) feet of material down to approximate elevation 0.00.
2. Regular maintenance and clearing of the outflow channels should be conducted. The existing outlet channel should be excavated to approximate elevation 0. The current outlet channel varies between elevation 0.59 to 1.99. The outlet invert is -0.16. This is currently completed under a maintenance assent with CRMC, however we recommend

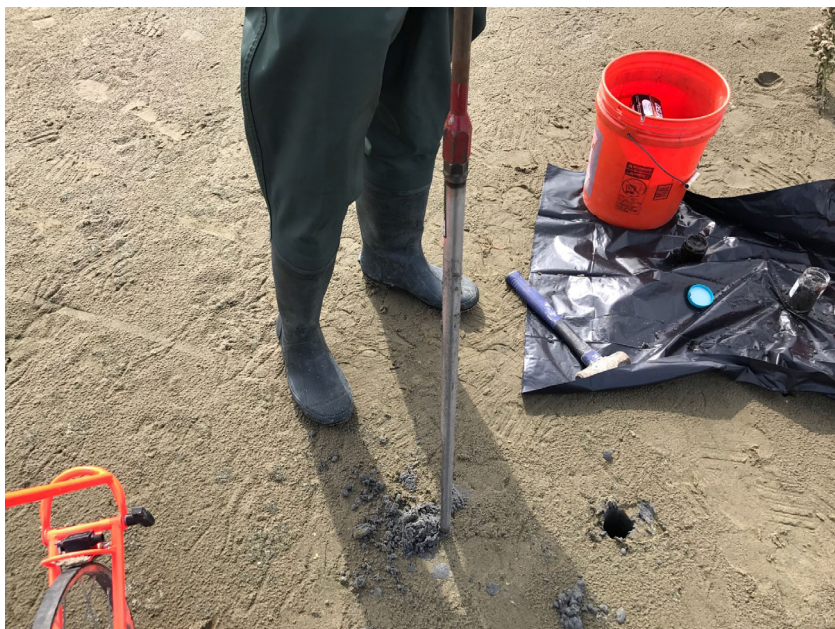
9) October 16, 2018. Dredge Sampling (Pond)

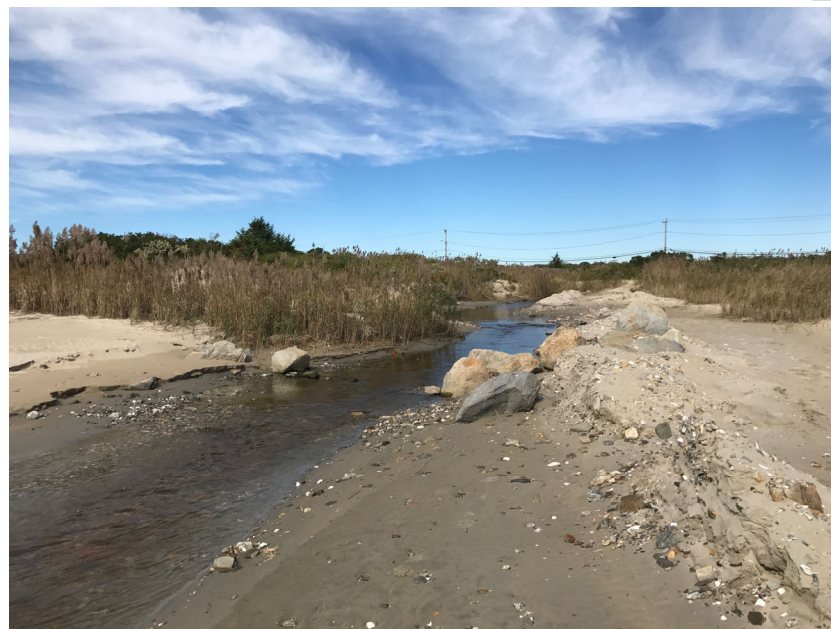
10) October 16, 2018. Outlet Channel (Beach Side)

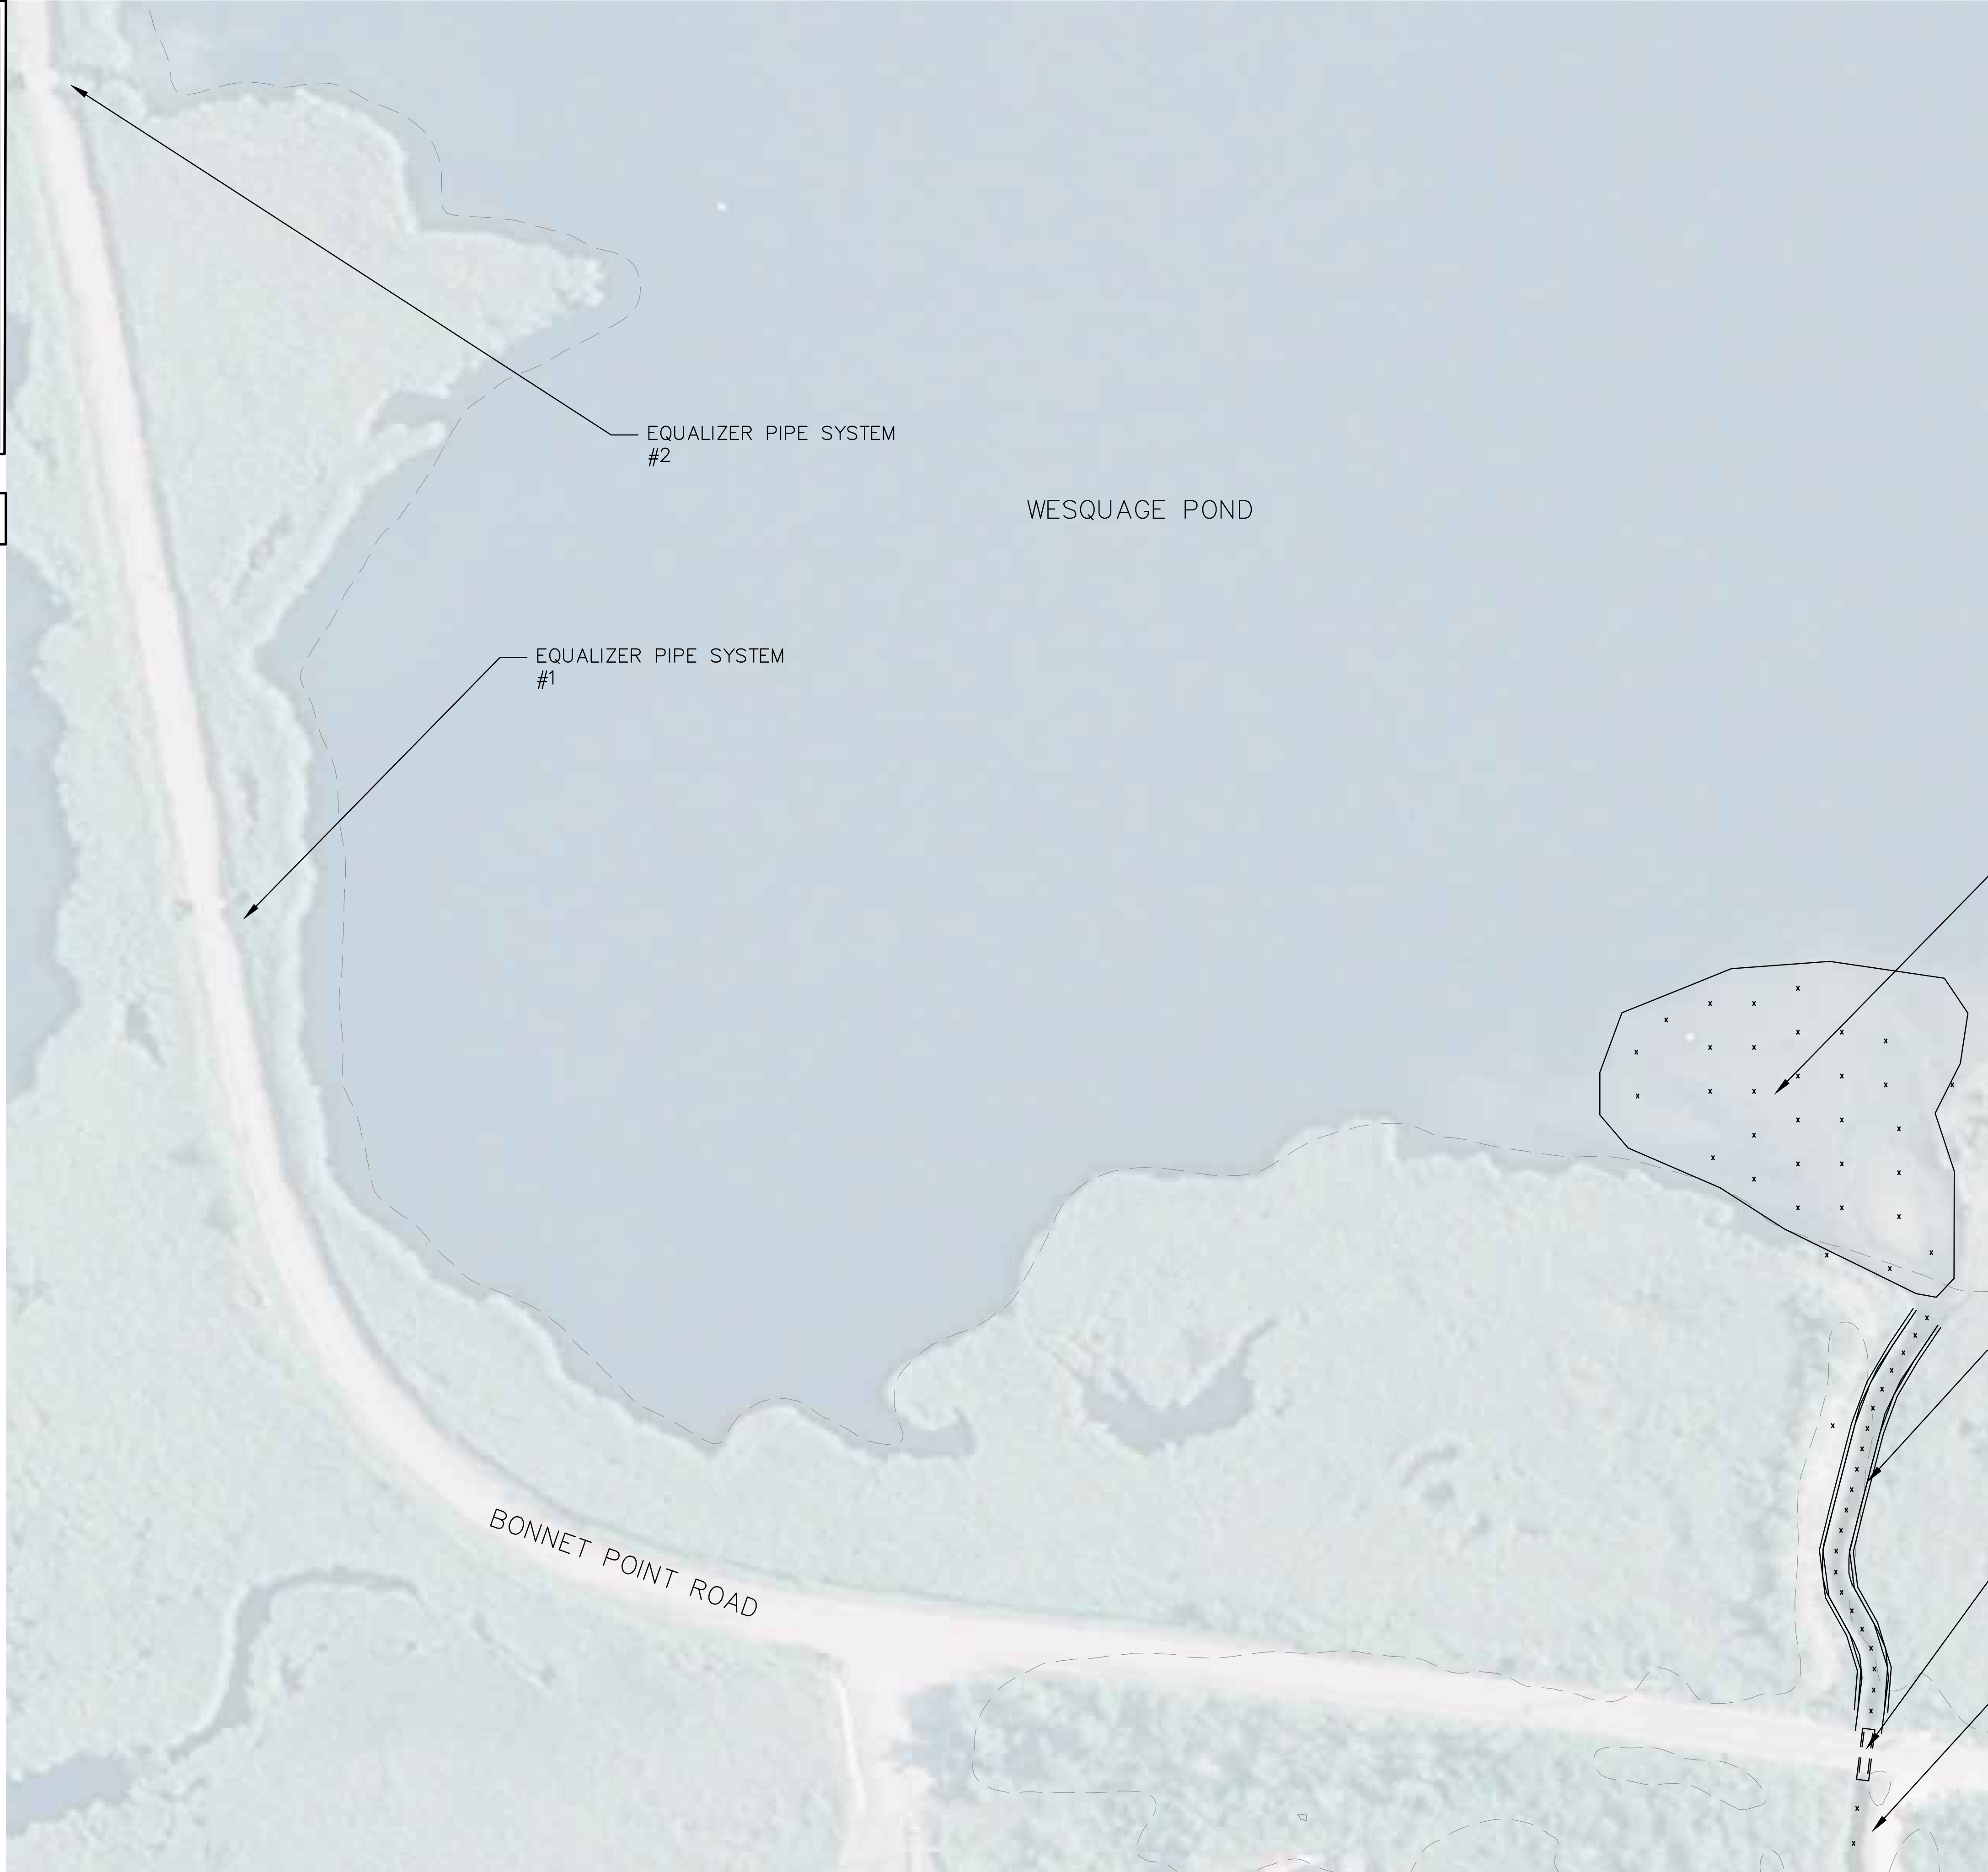
**SITE PLAN**  
SCALE: 1" = 50'

SAND ACCUMULATION AREA (30,000 SF)

EXISTING OFFFALL CHANNEL FROM WESQUAGE POND

EXISTING 3'X6' CONCRETE CULVERT

EXISTING OFFFALL CHANNEL TO NARRAGANSETT BAY
